# A shattering saga

Byron Bloch studies the latest crash test evidence and discovers how one simple change to side window glazing in vehicles can greatly improve the overall safety of passengers in rollover accidents

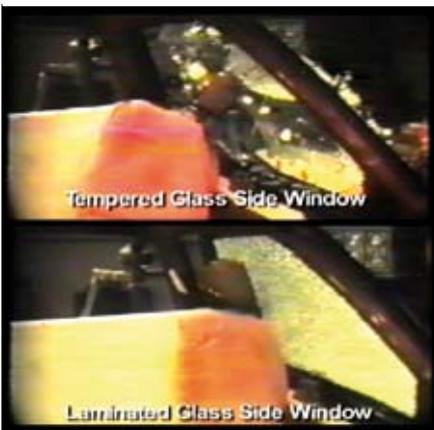
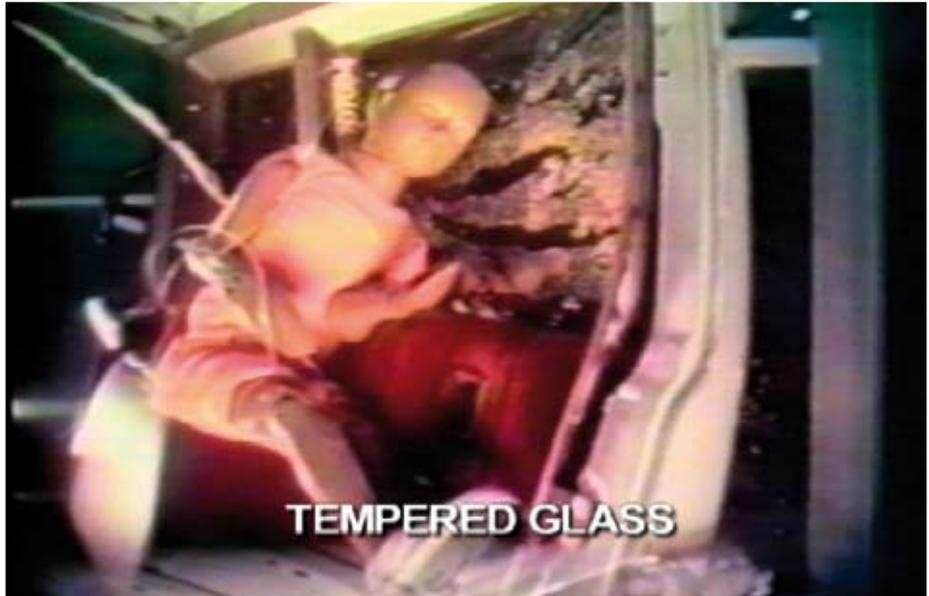
Below: The upper photo shows the dummy's head smashing completely through the tempered glass, en route to being partially or completely ejected from the vehicle in a side impact or rollover accident. The bottom photo shows the side window of laminated glass serving as a 'life net' to keep the dummy's head and body from partial or complete ejection. Right: A child test dummy is ejected outward through the large side window opening, when the tempered glass easily shatters upon impact by the occupant in a side impact or rollover accident. This is remarkably demonstrative of what happened in Case A (see page 8), in which a young girl was ejected out onto the road and severely injured

In the figures above, note how the dummy's head smashes into and is ejected through the tempered glass, but note the alternative laminated side window glass, which stays intact enough to serve as a life net and keep the test dummy safely within the vehicle. By staying intact, the laminated glass also helps contribute its support to help prevent the roof from buckling downward, as yet another safety advantage.

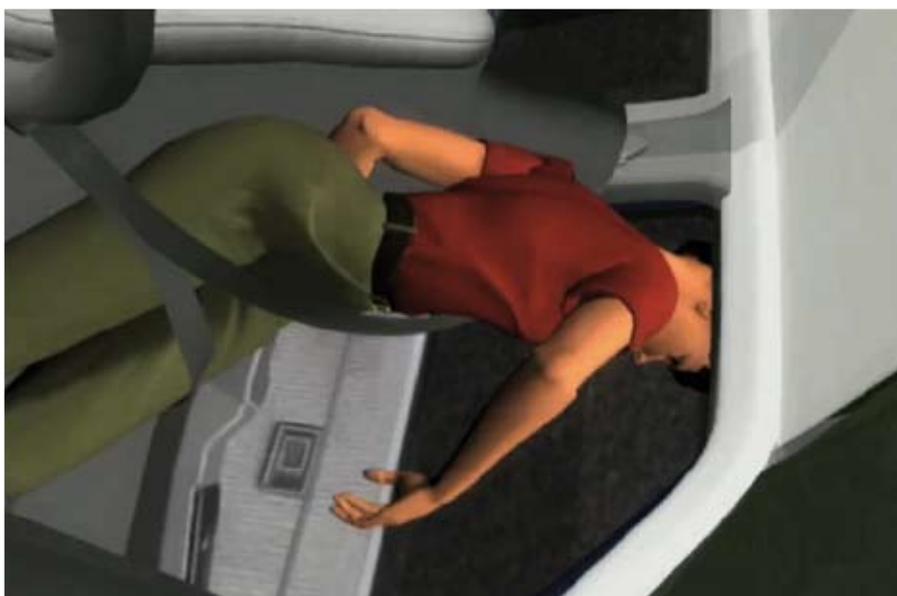
Left: Case B. This accident occurred when a Chevy Tahoe SUV was impacted and went out of control, and rolled over onto the driver's side. The woman driver was wearing her lap-and-shoulder seatbelt but, when the driver's door window glass shattered out during the rollover, she was partially ejected and impacted her head onto the road. This animation shows her ejection path through the window opening

Rhonda, a middle-aged woman, was driving her Chevy Tahoe SUV and was wearing her seatbelt. When struck in the rear corner by another car, the Tahoe SUV went out of control and rolled over. During the rollover sequence, the driver's side window's tempered glass shattered, causing Rhonda to be partially ejected and suffer massive, fatal head trauma. If the driver's side window glass had instead been of laminated glass, it would have stayed intact and served as a life net to prevent her from being partially ejected and killed.

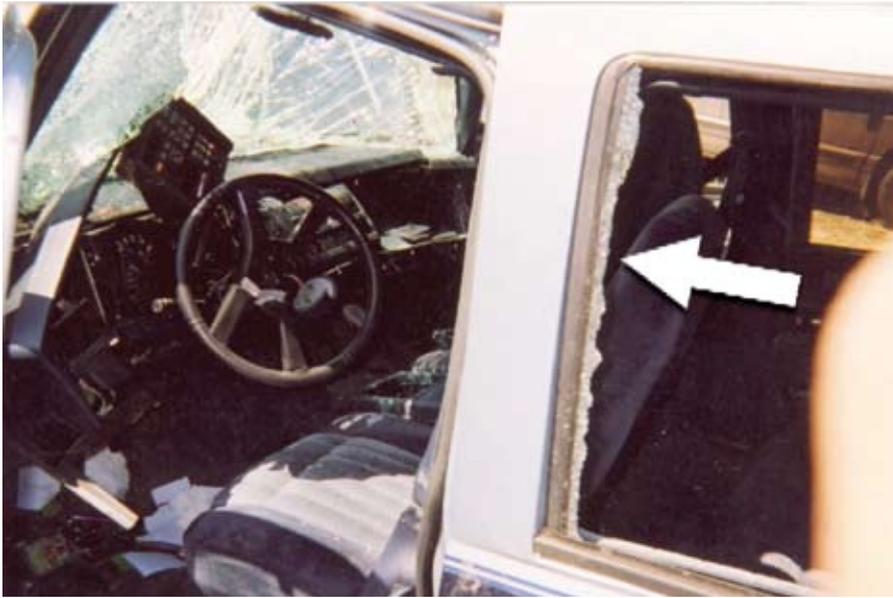
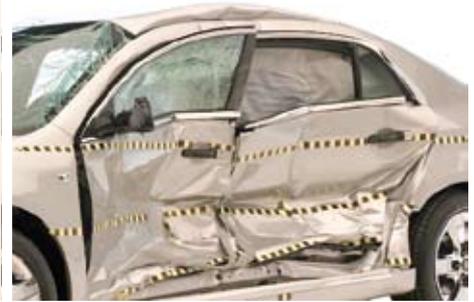
Left: Case A. In this Chevy Suburban SUV, a young girl was seated in the middle row seat, wearing her seatbelt. In the collision, the seatbelt buckle released and she was ejected out through the side window when the tempered glass shattered. The arrow shows glass particles embedded within the rubber molding. Below: IIHS side-impact test of a 2008 Chevrolet Malibu. Note that the laminated forward side glass stays intact, while the tempered rearward side glass shattered completely out.

Bethany, aged 11, was seat-belted on the second-row seat of a Chevy Suburban SUV. In a moderate collision, the seatbelt came unbuckled and she was ejected through the adjacent large side window opening as the tempered glass easily shattered. Bethany impacted her head on the road, incurring severe trauma to her face, skull and brain. If that large side window had been laminated glass, it would have stayed intact and served as a life net to prevent her from being ejected and severely injured. See figure above.
